# BELZONA ATTENTION ON THE ROOF

**Industry:** General Industry  
**Application:** RPA-Roof Problem Areas  
**Substrate:** Conventional four ply build up roof and brick  
**Products:** \* Belzona® 3111 (Flexible Membrane) ,  
\* Belzona® 9311 (Membrane Reinforcing Sheet) ,

**Customer Location:** U.S. Air Force Base in Illinois, USA  
**Application Date:** July 1995

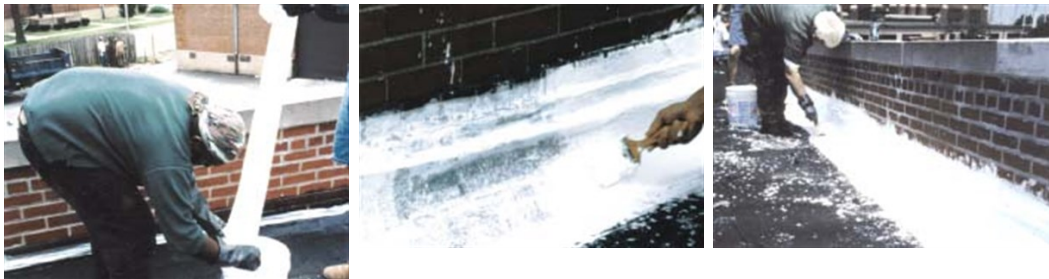
*This building had been renovated, severe leaks were destroying new ceiling tiles and wallpaper. Flashings were pulled away from the wall and water gushed in.*

- \* Belzona® 9311 (Membrane Reinforcing sheet) is pre-wetted prior to application. ,
- \* Second coat of Belzona® 3111 (Flexible Membrane) over first. ,
- \* The finishing touches. ,

The application was carried out in accordance with Belzona Know-How Leaflet RPA-8.

240 linear feet by 2 feet wide was coated in five hours. One hour later, a heavy rain blew in, there were no leaks and no damage to the Belzona® 3111 (Flexible Membrane). The roof is now watertight.
