BELZONA ATTENTION ON THE ROOF

ID: 172

Customer Location: U.S. Air Force Base in Illinois, USA
Application Date: July 1995

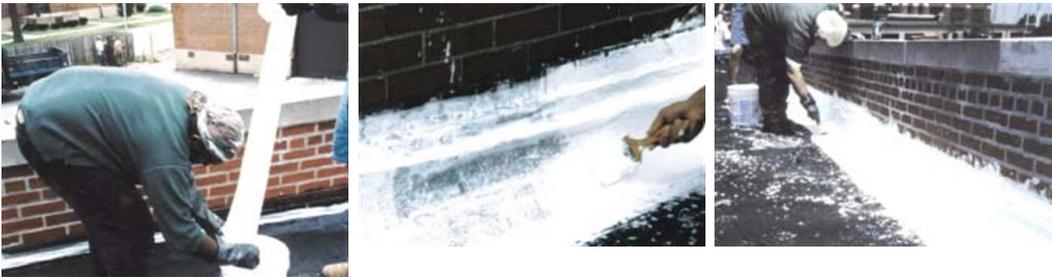
Photograph Descriptions

This building had been renovated, severe leaks were destroying new ceiling tiles and wallpaper. Flashings were pulled away from the wall and water gushed in.

- * Belzona® 9311 (Membrane Reinforcing sheet) is pre-wetted prior to application. ,
- * Second coat of Belzona® 3111 (Flexible Membrane) over first. ,
- * The finishing touches. ,

240 linear feet by 2 feet wide was coated in five hours. One hour later, a heavy rain blew in, there were no leaks and no damage to the Belzona® 3111 (Flexible Membrane). The roof is now watertight.
