BELZONA® REPAIRS A FRANCIS TURBINE

Customer Location: Hydroelectric power plant / Moulin
Neuf, France

Application Date: September 2009

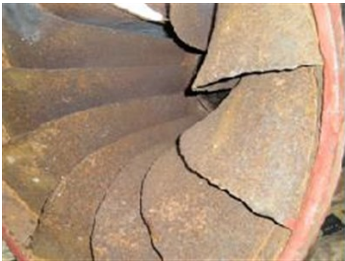
* Original turbine After disassembling After rebuilding with Belzona® 1311 Application of 2 coats of Belzona® 1321 ,

This turbine was in operation since 1976 and showed significant erosion-corrosion.
