BELZONA® REPAIRS A FRANCIS TURBINE

Customer Location: Hydroelectric power plant / Moulin Neuf, France

Application Date: September 2009

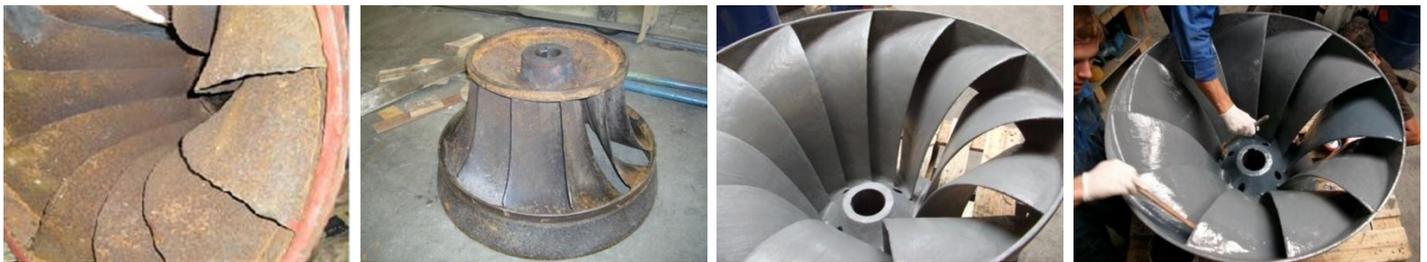
Photograph Descriptions

* Original turbine After disassembling After rebuilding with Belzona® 1311 Application of 2 coats of Belzona® 1321 ,

This turbine was in operation since 1976 and showed significant erosion-corrosion.

Based on previous experience and drawbacks of a hot applied solution, welding was not an option.

Application was carried out in accordance with Belzona Know-How System Leaflets CEP-3 & 5. Belzona® 1311 was used to restore profiles before overcoating with Belzona® 1321 to provide protection from further erosion-corrosion.

The Belzona solution has avoided the replacement of the turbine which would have cost between 30000€ and 50000€. About 50 hours of works were needed to repair this turbine and the repair cost 10000€ to the client.
