# BELZONA SEALANT FOR METHANE POWERED ENGINE PAD

Customer Location: *Wastewater Treatment Plant in Texas, U.S.A.*

Application: *FPA-Floor Problem Areas*

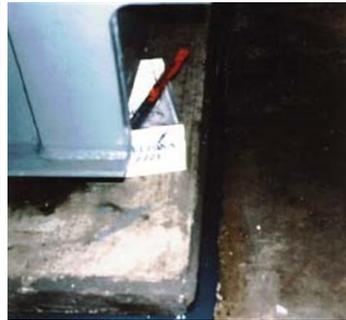
*Old cork expansion joint material hardened, allowing vibration to crack the floor outside of the joint area.*

- \* View of the engines used at wastewater plant. Three engines are located in powerhouse. ,
- \* Old cork removed and new backer rod installed. ,
- \* Finished application, Belzona® 2221 ready to handle vibration. ,

Application was carried out in accordance with Belzona Know-How Leaflet FPA-6.
