# BELZONA RESTORES VALVES TO BETTER THAN NEW CONDITION

Industry: *Pulp & Paper*  
Application: *VPF-Valves, Pipes and Fittings*  
Substrate: *Cast iron*  
Products: *\* Belzona® 1111 (Super Metal) ,*  
*\* Belzona® 9411 (Release Agent) ,*

Customer Location: *Paper Mill in Northwest Florida, U.S.A.*  
Application Date: *1992*

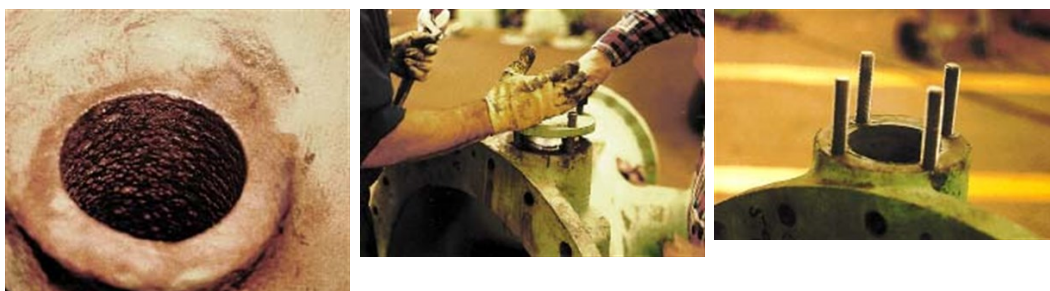
## Photograph Descriptions

*Housing had eroded/corroded to the point where the valve flap would not seat (seal) properly, allowing partial flow in the wrong direction*

- \* Corroded housing. ,
- \* Molding technique using fabricated dummy pin, Belzona® 1111 (Super Metal) and Belzona® 9411 (Release Agent) are employed.
- ,
- \* Finished repair. ,

The customer averted costly replacement or welding and line boring. Several valves were repaired. New flappers were installed and the inside of the valve bodies were rebuilt with Belzona® 1111 (Super Metal).
