BELZONA DAM LOCK SEALED

ID: 188

Customer Location: Dam in Florida, U.S.A.
Application Date: November 1998

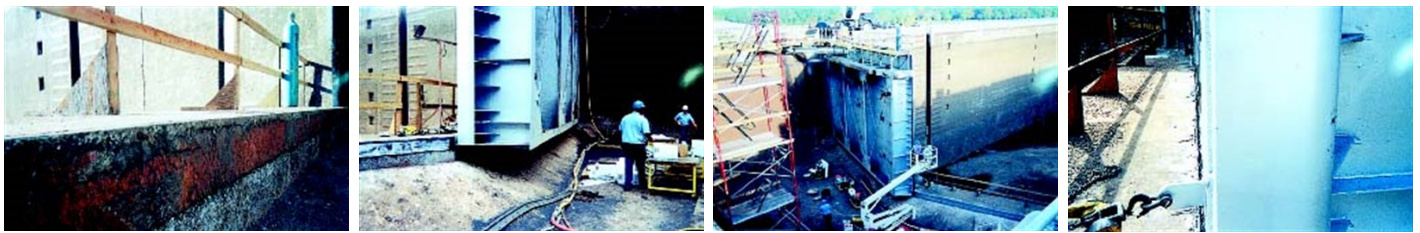
Photograph Descriptions

Lower seal on locks were leaking due to irregular metal-on-metal seal caused by cavitation.

- * The culprit ,
- * Surface preparation complete ,
- * Work in progress ,
- * The lock is sealed ,

Application was carried out in accordance with a modified version of Belzona Know-How leaflets GSS-5 and SOS-10a.

Tremendous coordination was necessary between the contractor and the Army Corp of Engineers. Each door of the lock is 47 feet wide. Following surface preparation by grit blasting, product was applied to one side, TurtleWax® used as release agent to entire length of door seal.
