# BELZONA QUICKLY RESTORES & UPGRADES TURBINE PROTECTION

Application: CEP-Centrifugal Pumps

Customer Location: Hydropower plant, France

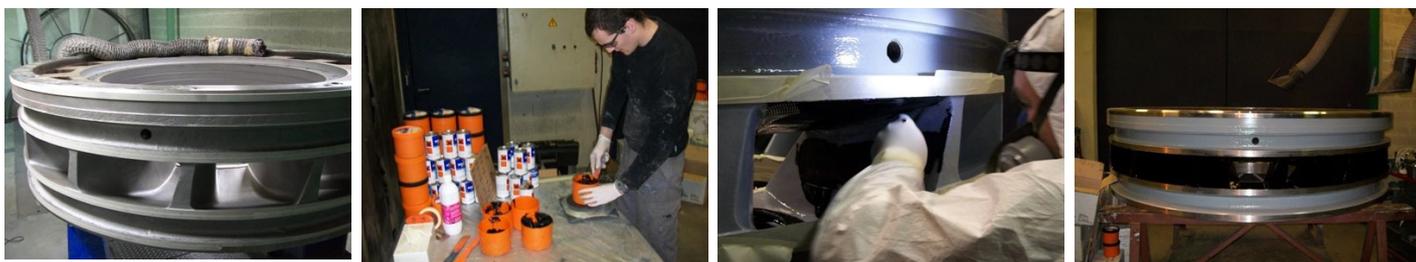
- \* Blasted runner prior to the application ,
- \* Mixing of Belzona® 2141 ,
- \* Application of Belzona® 2141 ,
- \* Completed equipment ,

A Francis turbine runner which had been previously coated 15 years ago.

Application was carried out in accordance with Belzona Know-How System Leaflet CEP-3. The bottom and top parts only needed a protection against corrosion and not erosion: Belzona® 5811 was used. The middle part had a serious problem of cavitation: Belzona® 1341 and Belzona® 2141 were used.
