BELZONA® 1591 PROTECTING COALESCER VESSEL

ID: 19

Application: TCC-Tanks and Chemical Containment Areas

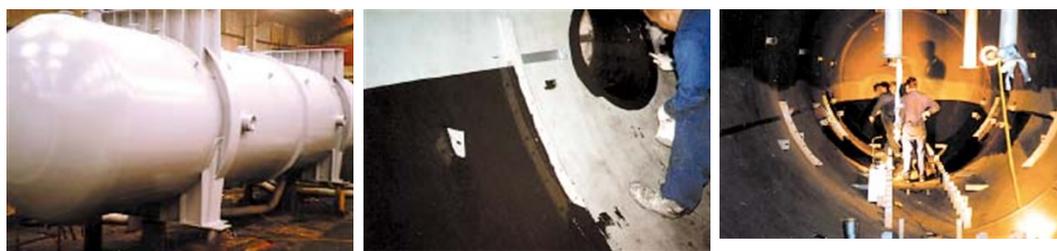
Corrosion was anticipated in the lower 1/3rd of the vessel. Design Temperatures were up to 150oC with sea water present.

- * The Coalescer vessel. ,
- * Application underway inside. ,
- * The lower 1/3rd was protected. ,

Coalescer vessel for installation on a Floating Oil Production and Storage vessel (an FPSO) destined for the North Sea.

Application was carried out in accordance with Belzona Know-How Leaflet TCC-5.

Belzona was chosen for vessel protection following extensive testing simulating the operating conditions expected. No other coating was available to withstand the operating temperatures and pressures. Metal cladding could not be carried out within the time constraints of this fast track project.
