BELZONA REINFORCES EXCAVATOR BEARING SEATS

ID: 1906

Application: GSS-Gaskets, Seals and Shims

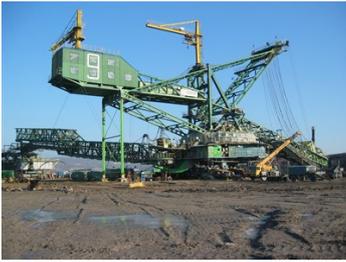
* Excavator profile Bonding the plates with Belzona® 1111 Preparation for injection Injection of Belzona® 5811; In the diagram, Belzona® 1111 is shown in blue and Belzona® 5811 in beige. ,

Rotary turntable bearing of one of their bucket wheel excavators used in the open cast strip mine (brown coal)

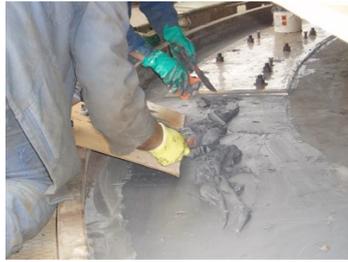
The steel plates of the bearing showed fretting and fatigue cracking under the 12 meter diameter turntable bearing.

Application was carried out using a modified version of Belzona Know-How System Leaflet GSS-9. 250kg of Belzona® 1111 was applied to bond the steel plates onto the casing of the turn table. The product was applied on the casing as well as on the steel plate. 220ltrs of Belzona® 5811 was injected between the first and the second stringer plate.
