BELZONA REINFORCES EXCAVATOR BEARING SEATS

ID: 1906

Customer Location: Open cast mine, Poland

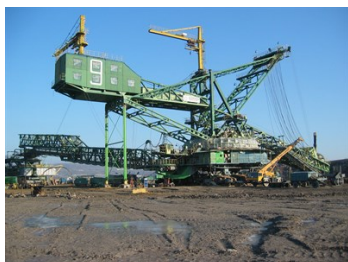
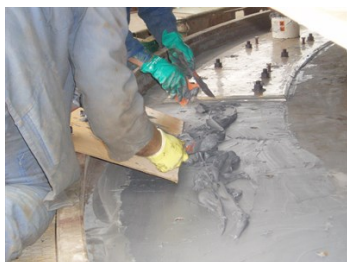
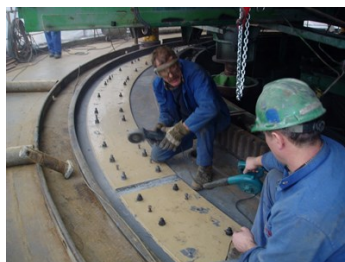
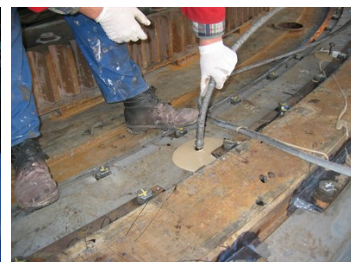
Photograph Descriptions

The steel plates of the bearing showed fretting and fatigue cracking under the 12 meter diameter turntable bearing.

* Excavator profile Bonding the plates with Belzona® 1111 Preparation for injection Injection of Belzona® 5811; In the diagram, Belzona® 1111 is shown in blue and Belzona® 5811 in beige. ,

Application was carried out using a modified version of Belzona Know-How System Leaflet GSS-9. 250kg of Belzona® 1111 was applied to bond the steel plates onto the casing of the turn table. The product was applied on the casing as well as on the steel plate. 220ltrs of Belzona® 5811 was injected between the first and the second stringer plate.
