BELZONA REINFORCES EXCAVATOR BEARING SEATS

ID: 1906

Rotary turntable bearing of one of their bucket wheel excavators used in the open cast strip mine (brown coal)

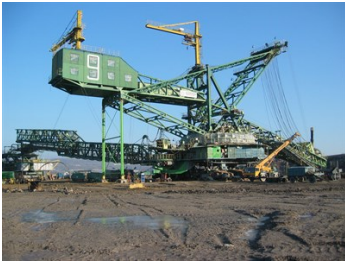
* Excavator profile Bonding the plates with Belzona® 1111 Preparation for injection Injection of Belzona® 5811; In the diagram, Belzona® 1111 is shown in blue and Belzona® 5811 in beige. ,

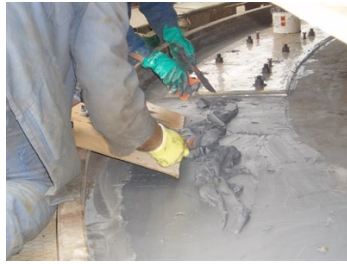
The steel plates of the bearing showed fretting and fatigue cracking under the 12 meter diameter turntable bearing.

Application was carried out using a modified version of Belzona Know-How System Leaflet GSS-9. 250kg of Belzona® 1111 was applied to bond the steel plates onto the casing of the turn table. The product was applied on the casing as well as on the steel plate. 220ltrs of Belzona® 5811 was injected between the first and the second stringer plate.
