BELZONA COMPLETES FULL REFURBISHMENT OF CHIMNEY STACK

ID: 1910

Application: WPA-Wall Problem Areas

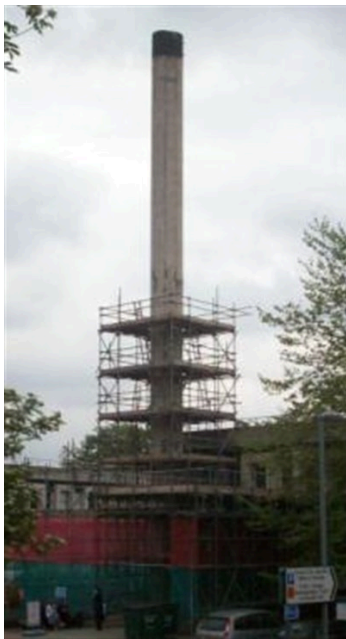
* The chimney stack being scaffolded for access Some of the cracks requiring repair Close view of the chimney after the application General view of the completed application ,

Application was carried out in accordance with Belzona Know-How System Leaflets WPA-1 & 4. The areas of damaged concrete were repaired with Belzona® 4141 before the chimney stack was fully coated with Belzona® 5151.

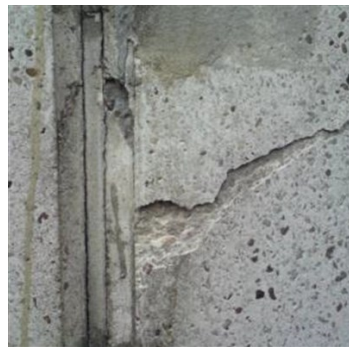
The chimney stack had several areas of spalled concrete due to moisture ingress.
