BELZONA COMPLETES FULL REFURBISHMENT OF CHIMNEY STACK

ID: 1910

Customer Location: Local council, UK

Application: WPA-Wall Problem Areas

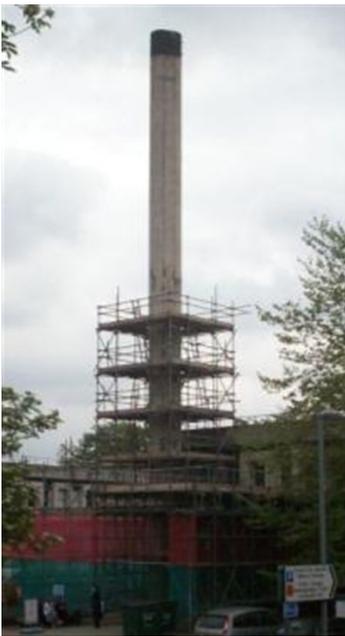
* The chimney stack being scaffolded for access Some of the cracks requiring repair Close view of the chimney after the application General view of the completed application ,

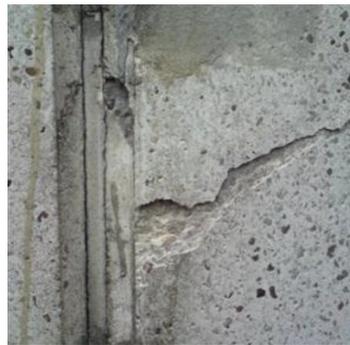
The chimney stack had several areas of spalled concrete due to moisture ingress.

Application was carried out in accordance with Belzona Know-How System Leaflets WPA-1 & 4. The areas of damaged concrete were repaired with Belzona® 4141 before the chimney stack was fully coated with Belzona® 5151.
