LONGEVITY PUMP REPAIR WITH BELZONA

ID: 1911

Industry: Water / Wastewater
 Application: CEP-Centrifugal Pumps
 Substrate: Cast Iron
 Products: * Belzona® 1391 (Ceramic HT),

Customer Location: District heating station, Sweden
 Application Date: 1998 and 2011

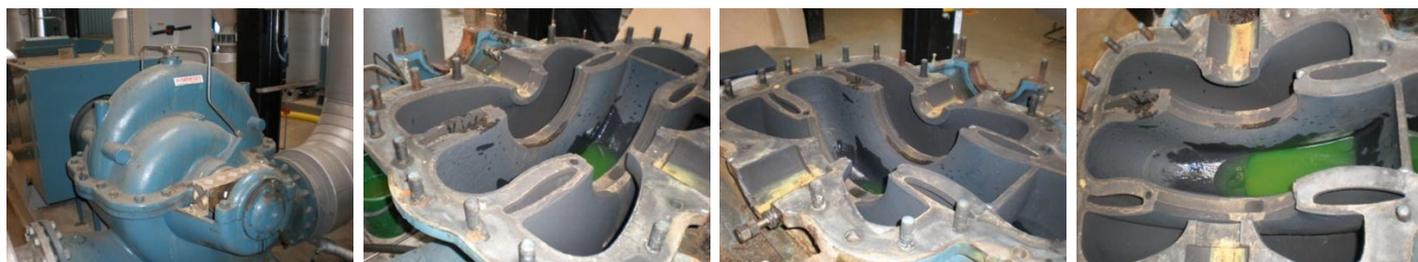
Photograph Descriptions

The pumps suffered from severe erosion/corrosion as they transport hot water at temperatures of 90-100 °C.

- * View of the pump ,
- * 3. & 4. Before cleaning after 13 years in service ,

The pumps had been in continuous use to provide the southern part of Stockholm with heat. After 13 years the pump was stripped to replace a seal and the coating was still as good as new and no effects from temperature or erosion could be seen.

Application was carried out in accordance with Belzona Know-How System Leaflet CEP-3.
