# BELZONA RESTORES COAL BOXES

Customer Location: A University's coal fired power plant in Western Massachusetts, U.S.A.

Application: SHM-Solids Handling Machinery

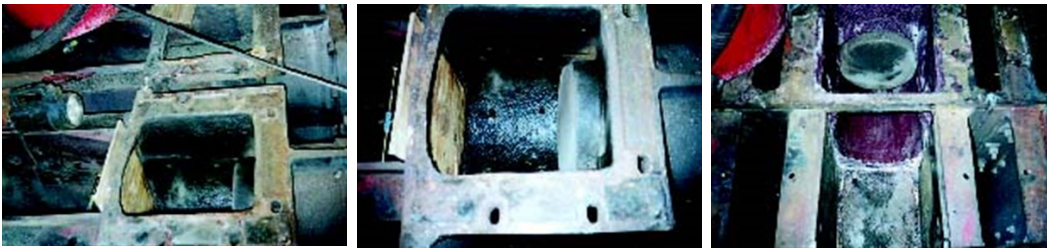
Coal boxes were worn from years of abrasion.

- \* View of surface preparation of the six coal boxes. ,
- \* Close-up of wear areas. ,
- \* Completed Belzona® 1811 (Ceramic Carbide) repair. ,

The application was carried out in accordance with a modified version of Belzona Know-How Leaflets SHM-13 and SHM-14.

The cost for replacing all six (6) coal boxes would have been \$21,000 plus additional installation costs. The Belzona repairs were carried out for approximately \$2,500. A one year inspection shows no signs of wear.
