# BELZONA REPAIRS 30 YEAR OLD VALVES

ID: 194

**Industry:** Water / Wastewater

**Customer Location:** Major irrigation district in central California, U.S.A.

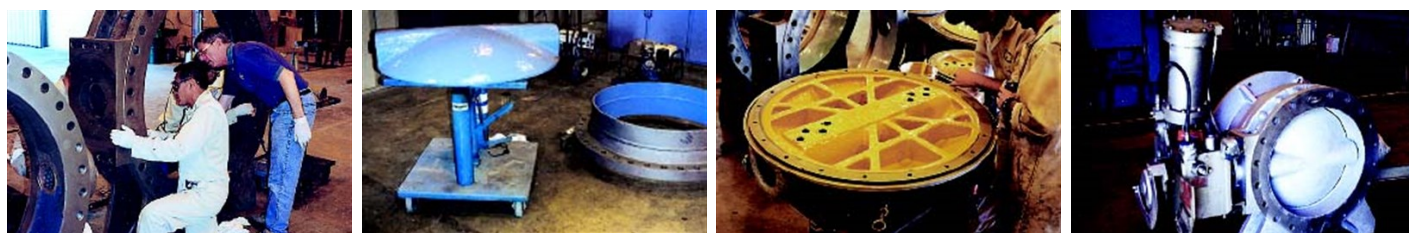
After 30 years of use, valves demonstrated severe damage from erosion-corrosion.

- \* Valves being inspected. ,
- \* Internal surfaces being protected with Belzona® 1341 (Supermetalgilde). ,
- \* External surfaces are coated with Belzona® 5811 (Immersion Grade). ,
- \* Completed valve, assembled and ready for service. ,

Application was carried out in accordance with Belzona Know-How Leaflets VPF-1 and VPF-2.
