# BELZONA EXPANSION BELLOWS REPAIR AT POWER PLANT

**Industry:** Power  
**Application:** VPF-Valves, Pipes and Fittings  
**Substrate:** Steel valve and rubber expansion joint.  
**Products:** \* Belzona® 2111 (D&A Hi Build Elastomer) ,  
\* Belzona® 2911 (QD Conditioner) ,

**Customer Location:** Power Plant in Texas, U.S.A.  
**Application Date:** September 1999

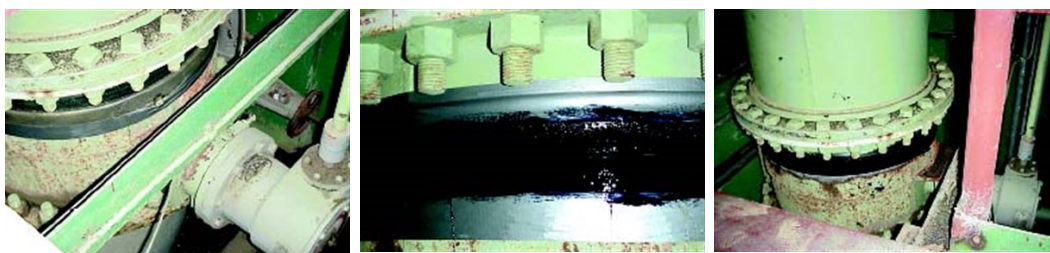
Early 1950's valve had a leaking expansion joint. In order to replace the expansion joint, customer would have had to replace the valve at an estimated cost of \$48,000.

- \* Expansion bellows after application of Belzona® 2911 ,
- \* Belzona® 2111 being applied to the surface of expansion joint ,
- \* Finished repair ,

Leaking expansion joint

The application was carried out in accordance with Belzona Know-How System Leaflet VPF-5.

Use of Belzona® 2111 (D&A Hi Build Elastomer) allowed the expansion joint to be repaired for less than \$2,000.
