BELZONA REPAIRS HYDROGEN COOLERS AND PIPING

Industry: Power
Application: HEX-Heat Exchangers
Substrate: Steel
Products: * Belzona® 1121 (Super XL-Metal) ,
* Belzona® 1341 (Supermetalgilde) ,

Customer Location: Power plant in Texas, U.S.A.
Application Date: May 1999

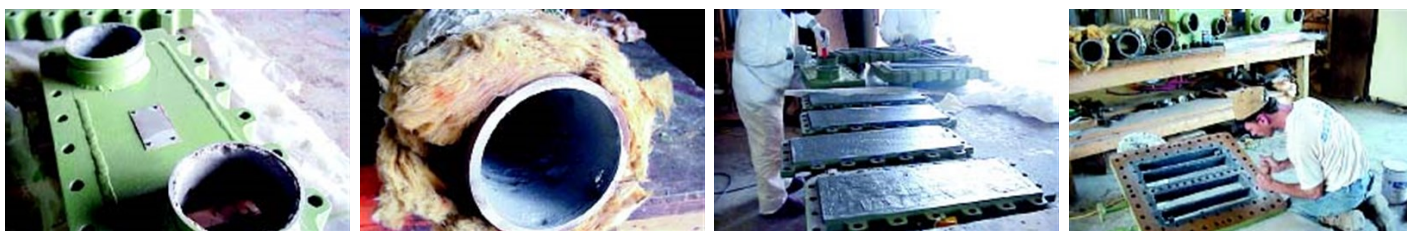
Photograph Descriptions

Years of erosion-corrosion on uncoated turbine cooler parts forced this customer to seek a repair solution as opposed to the high costs associated with replacement.

- * Close-up of erosion-corrosion in hydrogen coolers ,
- * Erosion-corrosion in hydrogen piping ,
- * Cooler heads being rebuilt with Belzona® 1121 ,
- * Finished pieces overcoated with Belzona® 1341 ,

Erosion-corrosion on hydrogen coolers and piping

Application was carried out out in accordance with Belzona Know-How System Leaflets HEX-2 and VPF-2.

Use of Belzona® 1121 (Super XL-Metal) overlayed with Belzona® 1341 (Supermetalgilde) allowed the hydrogen coolers to be repaired in a two-day process.
