# A BELZONA SOLUTION THAT HOLDS WATER

**Industry:** *General Industry*  
**Application:** *FPA-Floor Problem Areas*  
**Substrate:** *Limestone block and concrete*  
**Products:** *\* Belzona® 4141 (Magma Build) ,*  
*\* Belzona® 3111 (Flexible Membrane) ,*  
*\* Belzona® 4111 (Magma-Quartz) ,*

**Customer Location:** *The University of Iowa, U.S.A.*  
**Application Date:** *July 1997*

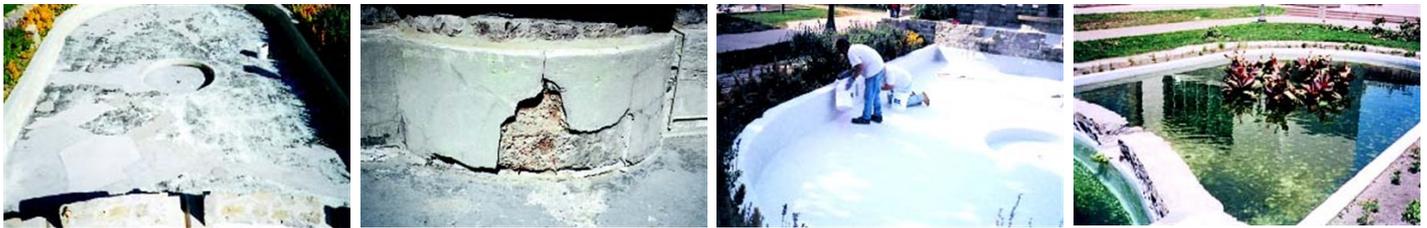
*The concrete and stone base was badly damaged with a large number of cracks and hollowed areas. Water was leaking into underground service tunnels. Previous repairs did not last for more than one year.*

- \* Overall view of the fountain ,
- \* Badly damaged concrete in the wall of the upper portion of the fountain ,
- \* Putting the finishing touches on the lower fountain area ,
- \* The fountain during 1999 - still trouble free ,

The Application was carried out in accordance with Belzona Know-How System Leaflets FPA-1, TCC-9, RPA-6 & RPA-11.

Inspection of the fountain in late 1999 revealed that the Belzona repairs were performing as anticipated. The fountain was donated to the university by the class of 1936.
