BELZONA RESTORES PERFORMANCE TO DIESEL POWERED GENERATOR

ID: 200

Customer Location: *Utility in West Texas U.S.A.*
Application Date: *December 1999*

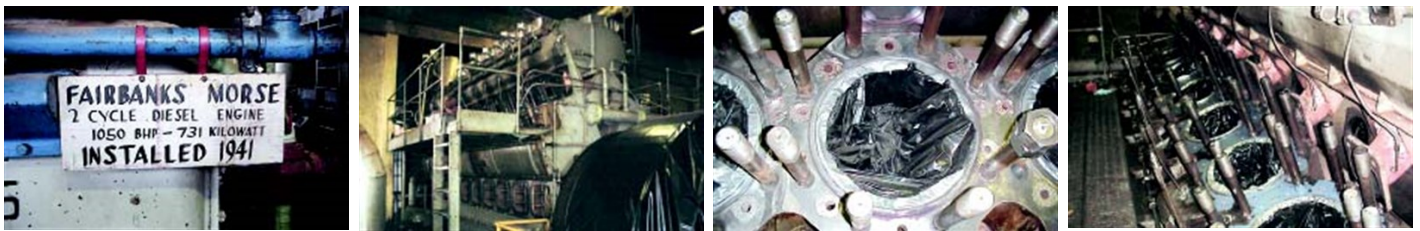
Photograph Descriptions

Pitting and corrosion on water jacket side of engine block. This made it impossible for O-ring fits to seal cooling water, allowing water to leak from under heads and into piston sleeves.

- * Close-up of 1941 diesel powered generator ,
- * Broad view of 1941 generator ,
- * Surface preparation of water ports ,
- * Application of Belzona®1391 to the top of the engine block ,

Application was carried out in accordance with a modified version of Belzona Know-How System Leaflet ENC-6.

After application was completed, surface was sanded and filed using in-house mechanics at a cost of \$5,000 (material and labor). This was much more cost effective than \$45,000 for welding and machining the engine block.
