BELZONA® 4131 REPAIRS TO SPALLED CONCRETE

ID: 203

Industry: *General Industry*
Application: *FPA-Floor Problem Areas*
Substrate: *Concrete and stainless steel*
Products: ** Belzona® 4131 (Magma-Screed) ,*

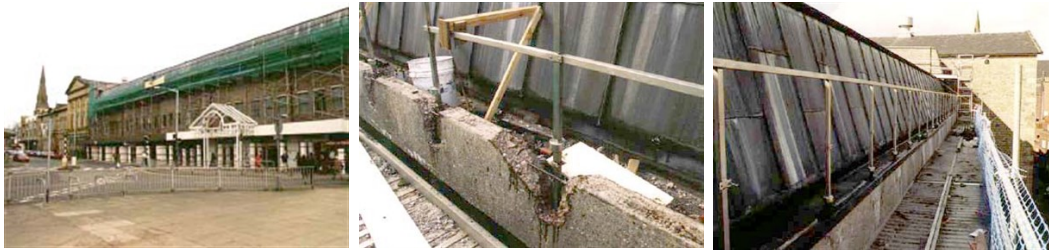
Extensive spalling had made using the hand-rail unsafe.

- * General view of the site with specially boarded up Acrows insisted on by safety officials ,
- * The degree of concrete damage clearly evident ,
- * Rebuilding complete and gutter re-instated ,

When work initially started damage was found to be more extensive than originally thought. Old railings were replaced. Rapid repairs with Belzona® 4131 ensured minimum disruption.
