# BELZONA REPAIRS TO STEEL ROLLING MILL

ID: 204

**Application:** GSS-Gaskets, Seals and Shims

**Application Date:** October 1997 and December 1999

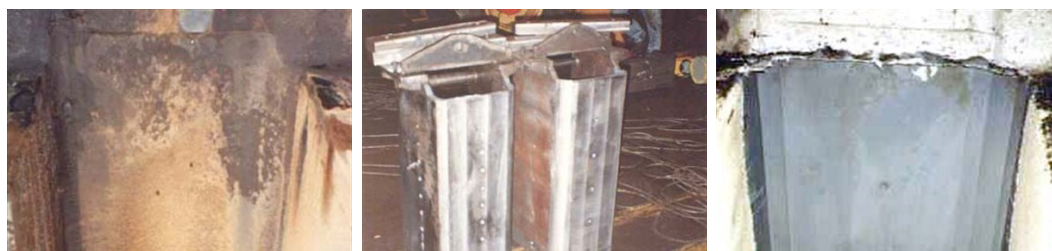
## Photograph Descriptions

Corrosion caused by cooling water between mill housing and load block. Increased clearance leads to loss of pre-tension on holding bolts.

- \* Corrosion evident after grit blasting ,
- \* Molds being positioned ,
- \* Surfaces reformed with Belzona ,

Application was carried out in accordance with a modified version of Belzona Know-How System Leaflet GSS-9.

First mill done in 1997 checked in 1999 and no change in clearances measured. Welding and machining considered but production losses would have been too great. Belzona application completed in 33-hour shut down with no production losses. Equipment and peripherals more reliable leading to increased quality and production.
