BELZONA REPAIRS TO STEEL ROLLING MILL

ID: 204

Application Date: October 1997 and December 1999

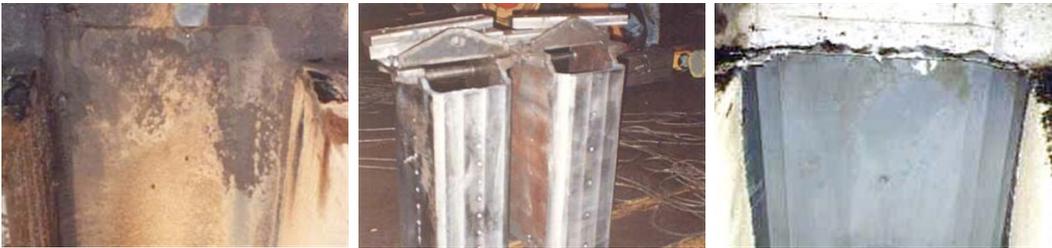
Photograph Descriptions

Corrosion caused by cooling water between mill housing and load block. Increased clearance leads to loss of pre-tension on holding bolts.

- * Corrosion evident after grit blasting ,
- * Molds being positioned ,
- * Surfaces reformed with Belzona ,

Application was carried out in accordance with a modified version of Belzona Know-How System Leaflet GSS-9.

First mill done in 1997 checked in 1999 and no change in clearances measured. Welding and machining considered but production losses would have been too great. Belzona application completed in 33-hour shut down with no production losses. Equipment and peripherals more reliable leading to increased quality and production.
