# BELZONA SEALS SWIMMING POOL LEAKS

**Industry:** General Industry  
**Application:** FPA-Floor Problem Areas  
**Substrate:** Concrete  
**Products:** \* Belzona® 4111 (Magma-Quartz),  
\* Belzona® 2211 (MP Hi-Build Elastomer),

**Customer Location:** Municipality  
**Application Date:** August 1999

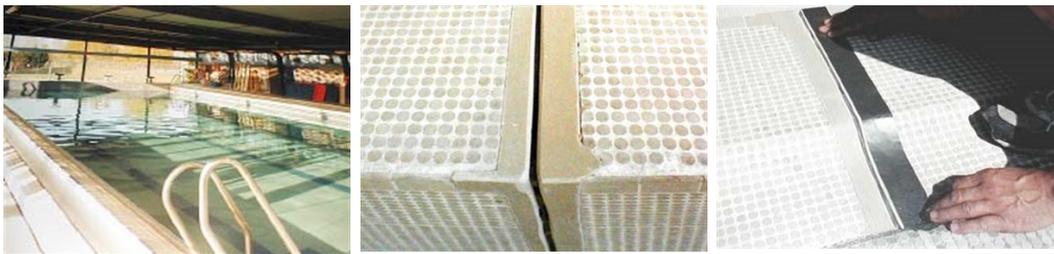
- \* General view of the pool ,
- \* Joint nosings rebuilt with tinted belzona® 4111 ,
- \* Joint being masked prior to sealing with Belzona® 2211 ,

The original Silicone sealant had deteriorated allowing large water losses.

Expansion joints in swimming pool

Application was carried out in accordance with Belzona Know-How System Leaflet FPA-6.

Water losses were estimated to cost \$3,300 per month (replacement, heating and treatment). This type of application has been carried out for 14 years with great success. The Belzona® 4111 is tinted blue, grey and beige to match the pool design.
