# BELZONA® 6111 PROTECTION OF FIRE HYDRANTS

ID: 206

**Industry:** *General Industry*  
**Application:** *TCC-Tanks and Chemical Containment Areas*  
**Substrate:** *Cast iron*  
**Products:** *\* Belzona® 6111 (Liquid Anode),*

**Customer Location:** *Municipality*  
**Application Date:** *1993 to present*

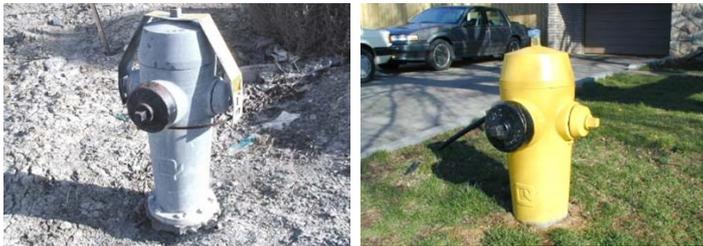
## Photograph Descriptions

*Ineffective primers used during manufacture led to repetitive painting. Road salt and grit during severe winter conditions accelerates corrosion.*

- \* Hydrant with Belzona® 6111 applied ,
- \* Completed application with top coat of paint applied ,

Application carried out in accordance with a modified version of Belzona Know-How System Leaflet TCC-5, before overpainting with required color top coat.

Customer carried out tests and found Belzona® 6111 to be the most effective system. Previous annual painting has been extended beyond five years.
