# BELZONA REFURBISHES SCRUBBER RUBBER

Customer Location: TVA Powerplant (Tennessee Valley Authority- U.S.A.)

Application: SHM-Solids Handling Machinery

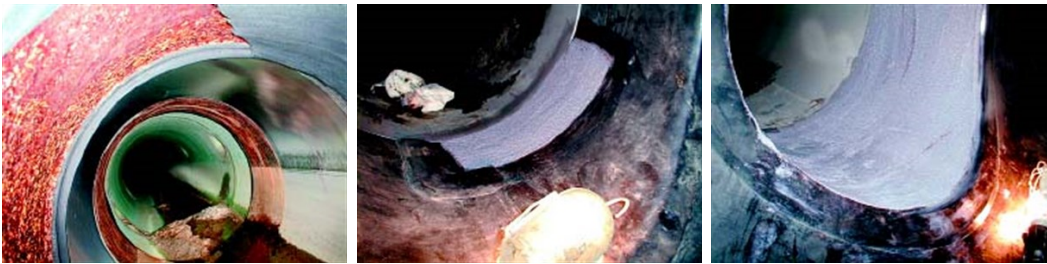
Once the rubber was gone, the exposed carbon steel would only last one week.

- \* Application begins ,
- \* Application continues ,
- \* Close-up view at a repaired area ,

Rubber lining on a scrubber unit was worn away leaving carbon steel exposed.

The application was carried out in accordance with a modified version of Belzona Know-How System Leaflets SHM-8 and SHM-9.

By utilizing the Belzona solution, wear on the carbon steel pipe was eliminated, thereby reducing maintenance costs and extending the life of the equipment.
