# BELZONA SEALS ACCESS RAMP LEAKS

ID: 2086

Customer Location: Recreation Center, BC, Canada  
Application Date: September 2002

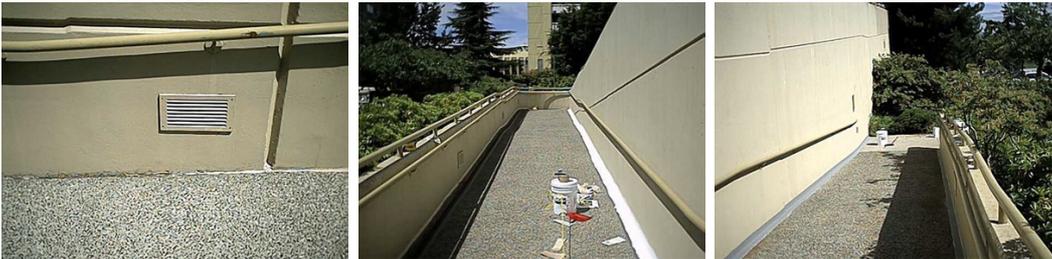
The caulking between the walls and ramp base needed to be replaced on a regular basis to prevent water from entering into the area below.

- \* View of joint to be sealed ,
- \* Application of 1st coat of Belzona® 3111 incorporating Reinforcement Sheet ,
- \* Completed application ,

Application carried out in accordance with Belzona Know-How System Leaflet RPA-1.

Belzona® 3111 Flexible Membrane was used to create a flexible flashing between the wall and floor eliminating the previous repetitive maintenance with sealants.
