A LEAK SEALING SOLUTION WITH BELZONA

ID: 209

Industry: *General Industry*
Application: *TCC-Tanks and Chemical Containment Areas*
Substrate: *Stainless steel*
Products: ** Belzona® 1111 (Super Metal) ,
* Belzona® 4341 ,*

Customer Location: *Chemical plant*
Application Date: *August 2000*

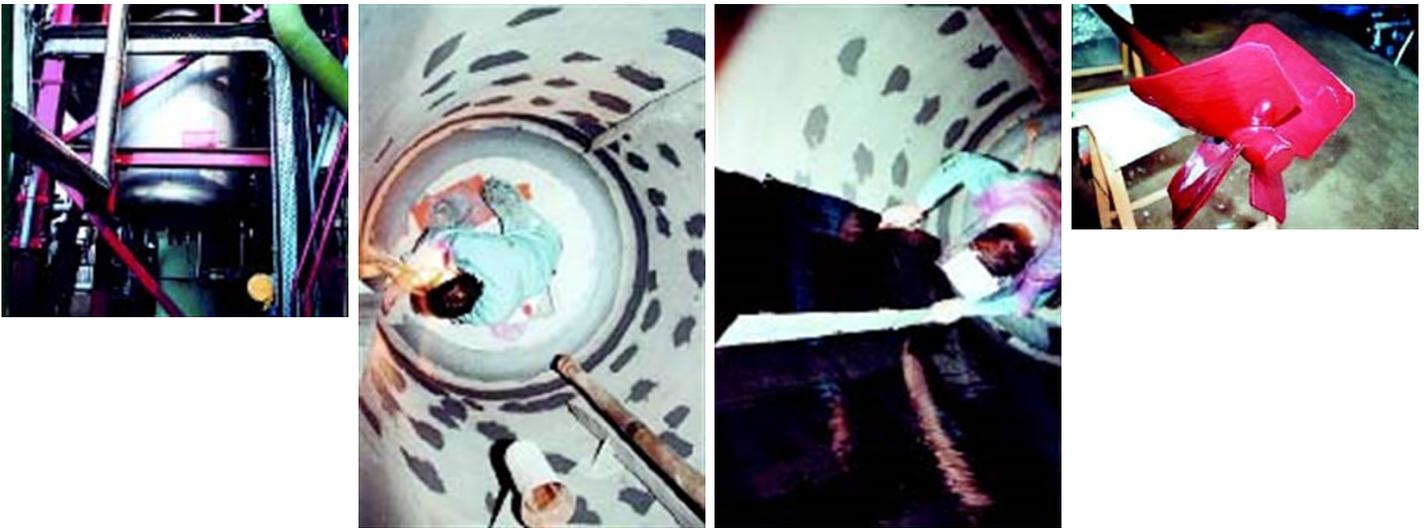
Leaks from chemical attack and galvanic corrosion. Chemicals included 30% concentrated sodium hydroxide, 65% concentrated sulphuric acid and 30% concentrated hydrochloric acid.

- * Stainless steel absorber vessel and agitator - general view ,
- * Applying Belzona® 1111 (Super Metal) to problem areas ,
- * Applying Belzona® 4341 ,
- * Protected agitator ready for service ,

Application was carried out out in accordance with Belzona Know-How System Leaflet TCC-5.
