BELZONA PROTECTS STRIPPER TOWER

Industry: Chemical & Petrochemical
Application: TCC-Tanks and Chemical Containment Areas
Substrate: Steel
Products: * Belzona® 1591 ,

Customer Location: Chemical Plant in Scotland
Application Date: October 1998

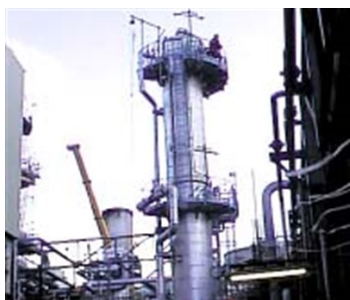
Erosion/corrosion caused by steam together with chlorides and other impurities.

- * General view of the Stripper Tower ,
- * Application underway in the confined space of the Tower ,
- * Application continues ,

Original glass flake lining failed and protection required to keep the tower in service to next major shut-down.
