# BOILING WATER: NO PROBLEM FOR BELZONA® 4181

Industry: *General Industry*  
Application: *FPA-Floor Problem Areas*  
Substrate: *Concrete*  
Products: *\* Belzona® 4181 ,*

Customer Location: *Hospital*  
Application Date: *July 2000*

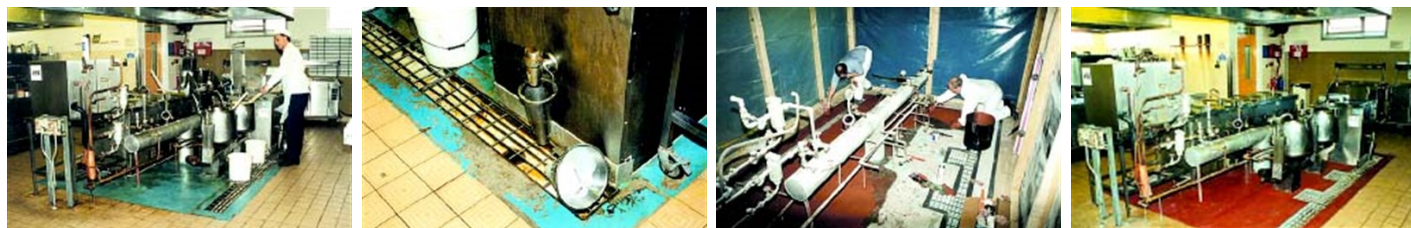
## Photograph Descriptions

*Boiling water had broken down an existing epoxy coating and the underlying concrete floor it was supposed to protect.*

- \* General view of floor problem area ,
- \* Close-up of damaged area around drainage channel ,
- \* Belzona® 4181 application underway ,
- \* The finished application ,

Application was carried out out in accordance with Belzona Know-How System Leaflets FPA-1 & FPA-3.

The area was tented to protect the surrounding area and the remaining coating was removed. Belzona® 4181 was able to withstand the boiling water and is now being considered for other application areas.
