BOILING WATER: NO PROBLEM FOR BELZONA® 4181

Industry: *General Industry*
Application: *FPA-Floor Problem Areas*
Substrate: *Concrete*
Products: ** Belzona® 4181 ,*

Customer Location: *Hospital*
Application Date: *July 2000*

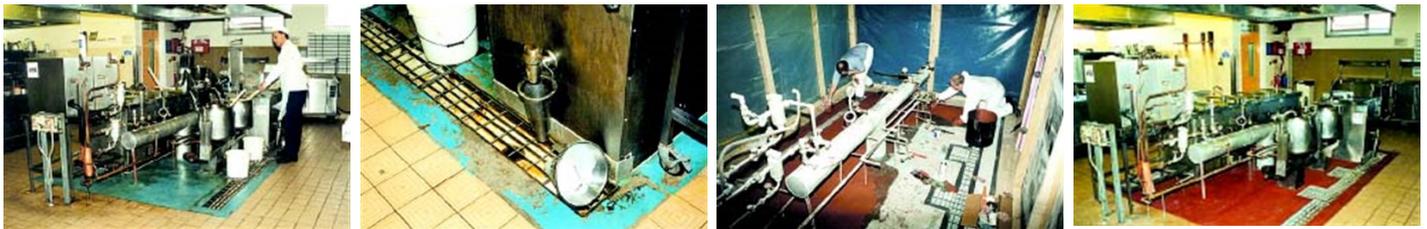
Photograph Descriptions

Boiling water had broken down an existing epoxy coating and the underlying concrete floor it was supposed to protect.

- * General view of floor problem area ,
- * Close-up of damaged area around drainage channel ,
- * Belzona® 4181 application underway ,
- * The finished application ,

Application was carried out in accordance with Belzona Know-How System Leaflets FPA-1 & FPA-3.

The area was tented to protect the surrounding area and the remaining coating was removed. Belzona® 4181 was able to withstand the boiling water and is now being considered for other application areas.
