BELZONA REPARÉ LES FUITES D'HUILE SUR LES AILETTES D'UN TRANSFORMATEUR

Localisation du client: *Station de distribution électrique,
Royaume-Uni*

Transformateur électrique refroidi à l'huile.

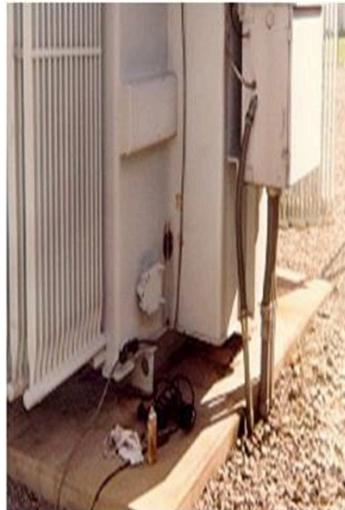
Fuites d'huile des ailettes.

* 1. Vue d'ensemble du transformateur. 2. Vue de près de la zone de fuite de l'huile. 3. Application achevée. Fuite étanchée avec Belzona 1161. ,

L'application a été effectuée en accord avec la procédure Belzona VPF-11a, utilisant un produit Belzona tolérant de l'état de surface

Le besoin coûteux de drainer l'huile afin d'effectuer la réparation a été éliminé. La réparation Belzona a été réalisée en moins de 2 heures et s'est avérée être un succès total.
