# BELZONA REPARÉ LES FUITES D'HUILE SUR LES AILETTES D'UN TRANSFORMATEUR

ID: 2128

Localisation du client: *Station de distribution électrique, Royaume-Uni*

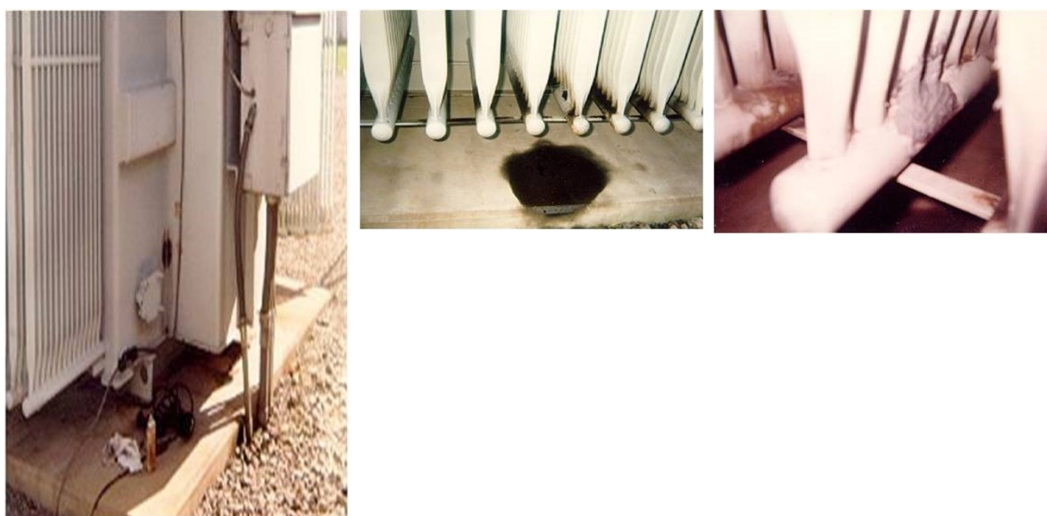
*Fuites d'huile des ailettes.*

\* 1. Vue d'ensemble du transformateur. 2. Vue de près de la zone de fuite de l'huile. 3. Application achevée. Fuite éliminée avec Belzona 1161. ,

L'application a été effectuée en accord avec la procédure Belzona VPF-11a, utilisant un produit Belzona tolérant de l'état de surface

Le besoin coûteux de drainer l'huile afin d'effectuer la réparation a été éliminé. La réparation Belzona a été réalisée en moins de 2 heures et s'est avérée être un succès total.
