# BELZONA PROTECTS NEW STAINLESS STEEL CONES

ID: 213

Industry: *Power*  
Application: *SHM-Solids Handling Machinery*

Customer Location: *Power Plant in Florida, U.S.A.*  
Application Date: *October 2000*

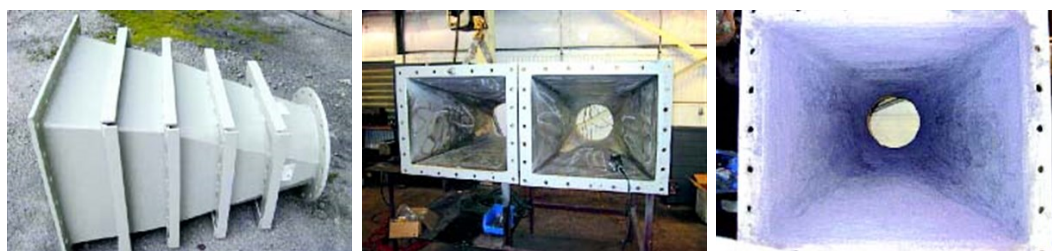
## Photograph Descriptions

*Impact and abrasion from coal, coupled with high temperatures caused severe wear to the cone walls.*

- \* New cone prior to application ,
- \* Blasted cones ,
- \* Protected cone with Belzona® 1812 that is ready for service ,

The application was carried out in accordance with Belzona Know-How System Leaflet SHM-13.

The plant had been replacing the cones every five years with difficult access. Belzona® 1812 offered great flexibility to their program by providing long term protection against premature wear.
