# BELZONA PROTECTS WELD SEAMS IN RECYCLING DRUM

**Industry:** Pulp & Paper  
**Application:** TCC-Tanks and Chemical Containment Areas  
**Substrate:** Carbon steel and weld material  
**Products:** \* Belzona® 1111 (Super Metal) ,  
\* Belzona® 1321 (Ceramic S-Metal) ,

**Customer Location:** Papermill in the Netherlands  
**Application Date:** February 1998

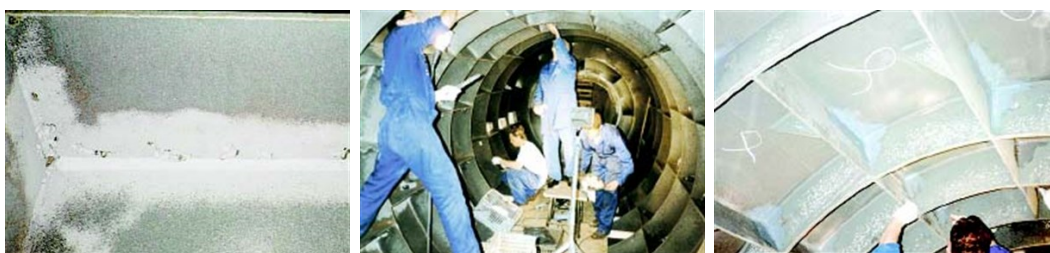
The debris settles in the 90 degree angles of the weld seams. The 60°C (140°F) environment with a pH 10 leads to galvanic and crevice corrosion of the weld seams.

- \* Weld seams after grit blasting ,
- \* Work in progress applying Belzona in the drum ,
- \* Some of the completed repairs ,

The application was carried out in accordance with Belzona Know-How System Leaflet TCC-5.

The Belzona repair was inspected in April 2000 and there were no signs of wear, breakdown or further corrosion.
