BELZONA SAVES REPLACEMENT COSTS

ID: 216

Industry: *Mining & Quarrying*
Application: *MPT-Mechanical Power Transmission*

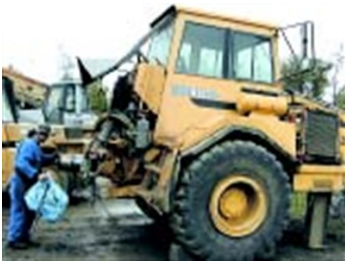
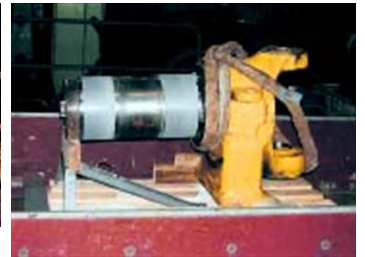
The ends of the shaft were worn due to play in the joint.

* The power unit The damaged shaft Application of the Belzona® 1111 underway The completed repair ,

The application was carried out in accordance with Belzona Know-How System Leaflet MPT-1.

The Belzona repair saved replacement costs estimated at \$7,250 plus delays in sourcing the parts. The Belzona repair allowed the equipment to continue in service with minimal interruption to production.
