BELZONA RAPID REPAIR TO VIADUCT RAILING SUPPORT

ID: 2161

Application: *FPA-Floor Problem Areas*

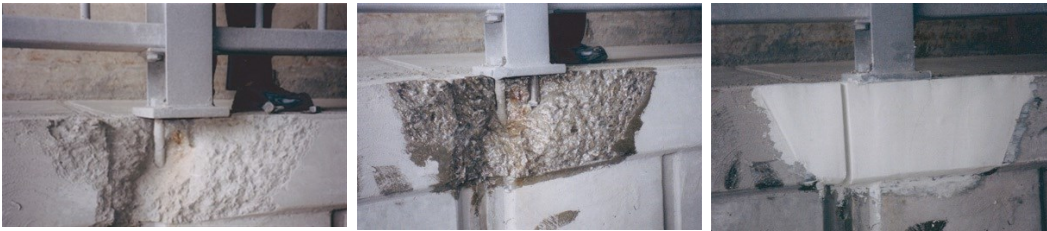
The concrete base for railings support pillars was cracked and spalled.

* Concrete condition before the application The concrete is coated with Belzona® 4911 Conditioner Belzona® 4141 application completed quickly and easily without the use of formwork ,

Application was carried out in accordance with Belzona Know-How System Leaflet FPA-10.

The application was achieved in 2 hours and without the need for any formwork. This application is still in excellent condition when inspected in 2011.
