# BELZONA RAPID REPAIR TO VIADUCT RAILING SUPPORT

ID: 2161

Customer Location: *Town council, Canada*  
 Application Date: *May 2003*

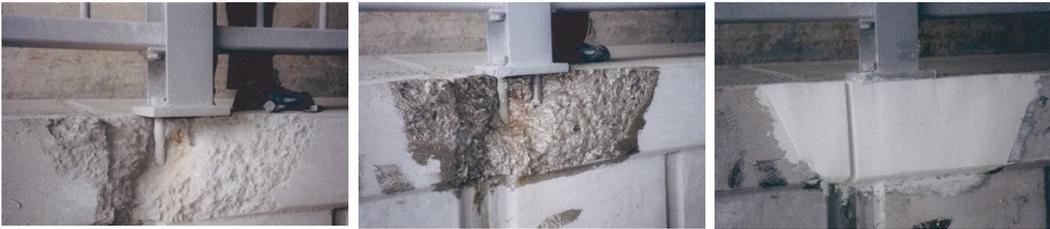
*The concrete base for railings support pillars was cracked and spalled.*

\* Concrete condition before the application The concrete is coated with Belzona® 4911 Conditioner Belzona® 4141 application completed quickly and easily without the use of formwork ,

Application was carried out in accordance with Belzona Know-How System Leaflet FPA-10.

The application was achieved in 2 hours and without the need for any formwork. This application is still in excellent condition when inspected in 2011.
