BELZONA AVOIDS SLIP PROBLEMS

ID: 2162

Industry: *Mining & Quarrying*
Application: *SHM-Solids Handling Machinery*

Drive drums from conveyor system

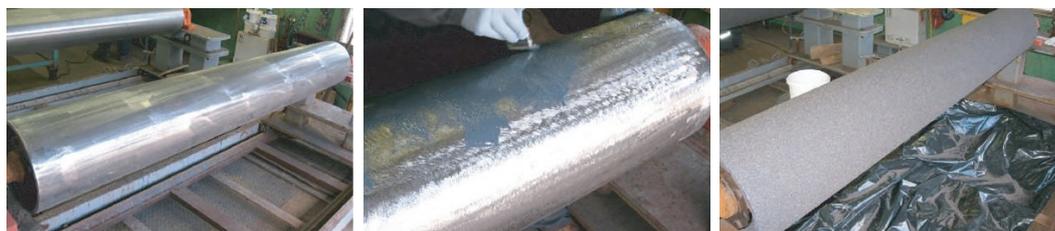
Photograph Descriptions

The belt was slipping on the drive rollers due to water from the poor seasonal weather.

- * Steel roller ,
- * After preparation, coating with Belzona® 1321 ,
- * Finished roller ,

Two drive rollers were treated and performed perfectly for a full year without any evidence of slipping. The Belzona Grip System has performed better than rubber and other lagging systems previously used.
