BELZONA PROVIDES PROTECTION FROM HOT GASES AT WATER TREATMENT PLANT

ID: 2167

Customer Location: *Water treatment plant, Slovakia*
 Application Date: *March 2011*

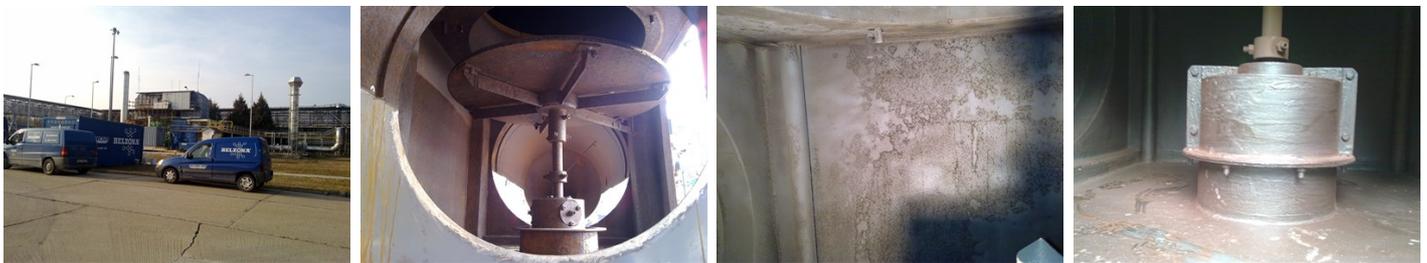
Sulphides, Sulphates, Chlorides, Ammonia, etc. in the gas caused pitting corrosion in the unit after 10 months.

- * General view of the reactor ,
- * Corrosion before repair ,
- * After grit blasting pitting corrosion clearly evident ,
- * Inspection after 6 months showed no damage or defects on the coating ,

Application was carried out in accordance with Belzona Know-How System Leaflet TCC-5. After grit blasting and chemical cleaning, areas were coated with Belzona® 1392 or Belzona® 4311 (depending on temperature).

Based on high temperature and various chemicals present, Belzona solution was chosen. After more than 12 months in service no

defects have occurred and equipment remains fully protected.
