# BELZONA PROVIDES PROTECTION FROM HOT GASES AT WATER TREATMENT PLANT

**Industry:** Water / Wastewater  
**Application:** TCC-Tanks and Chemical Containment Areas  
**Substrate:** Stainless steel (AISI 304 L)  
**Products:** \* Belzona® 1392 ,  
 \* Belzona® 4311 (Magma CR1) ,

**Customer Location:** Water treatment plant, Slovakia  
**Application Date:** March 2011

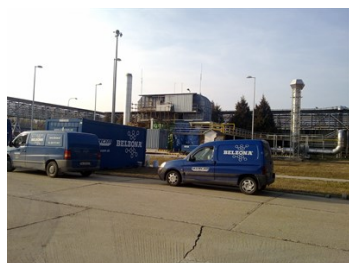
- \* General view of the reactor ,
- \* Corrosion before repair ,
- \* After grit blasting pitting corrosion clearly evident ,
- \* Inspection after 6 months showed no damage or defects on the coating ,

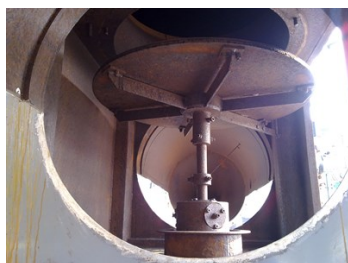
*Sulphides, Sulphates, Chlorides, Ammonia, etc. in the gas caused pitting corrosion in the unit after 10 months.*

Application was carried out in accordance with Belzona Know-How System Leaflet TCC-5. After grit blasting and chemical cleaning, areas were coated with Belzona® 1392 or Belzona® 4311 (depending on temperature).
