BELZONA PROTECTS HYDROELECTRIC TURBINE RUNNER

ID: 218

Customer Location: Hydroelectric power plant in Scotland
Application Date: November 2000

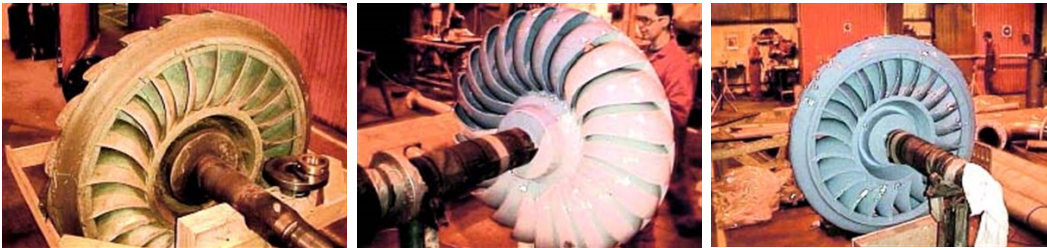
Photograph Descriptions

Over 40 years of service led to cavitation and corrosion.

- * The runner prior to application ,
- * Application underway with second coat of Belzona® 1341 being applied ,
- * The completed application with the smoothness of Belzona® 1341 clearly evident ,

The application was carried out in accordance with Belzona Know-How System Leaflets CEP-3 and CEP-5.

Conventional weld repairs would have been cost prohibitive. In addition, Belzona repairs do not create heat stress, an increase in efficiency is expected. The turbine does not operate full time. In summer there is often only enough water for operation one day per week.
