BELZONA KEEPS WORN HOSE WORKING

ID: 220

Industry: *General Industry*
Application: *SOS-Ships and Offshore Structures*

Substrate: *Rubber*
Products: ** Belzona® 2311 (SR-Elastomer),*

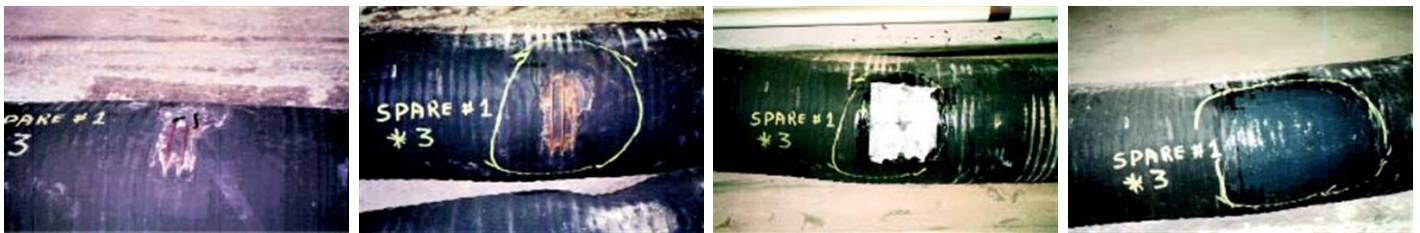
Photograph Descriptions

The uploading cement hose had worn through to the reinforcement wire.

- * Overview of damaged area ,
- * Loose pieces have been removed ,
- * The conditioner, reinforcement sheet and Belzona® 2311 (SR-Elastomer) have been used to fill area ,
- * The finished repair ,

Worn rubber hose

Application was carried out in accordance with Belzona Know-How System Leaflet SOS-12.
