BELZONA REPAIRS ORE BRIDGE CRANE AT BLAST FURNACE

ID: 221

Customer Location: *Steel Mill in Ohio, U.S.A.*
Application Date: *1994*

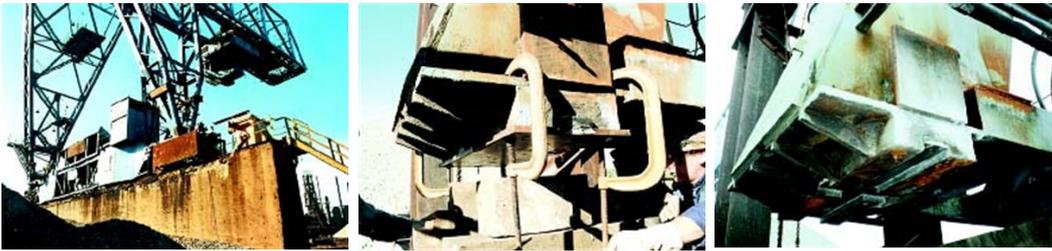
Photograph Descriptions

Worn keyways on the truck which moves the crane on the rails. The conventional method to solve this problem would be to machine new bases and keys. Entailing the crane being shut down for 3 to 4 days.

- * Overall view of Ore Bridge crane ,
- * Template "C"- clamped in place ,
- * Finished keyway with no machining required ,

Worn keyways.

A template with new key stock was made. The template was coated with Belzona® Release Agent and positioned beneath the cranes pedestal. Belzona® 1111 (Super Metal) was then applied.

Twenty-four hours later the Ore bridge was back in operation, preventing a 3 to 4 day shutdown to weld and machine a new keyway.
