BELZONA EXTENDS THE LIFE OF HEAT EXCHANGER END COVERS

ID: 2237

Application: HEX-Heat Exchangers

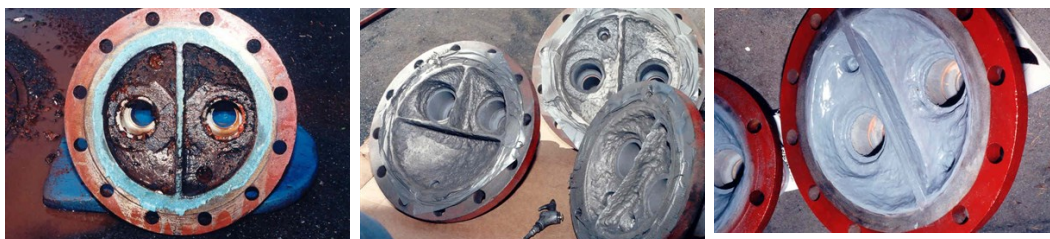
Photograph Descriptions

The heat exchanger unit end covers had become so badly eroded that they were potentially scrap.

- * View of corroded end covers after they had been removed ,
- * End covers after grit blasting ,
- * End covers rebuilt and coated ,

The application was carried out in accordance with Belzona Know-How System Leaflets HEX-2 & 3.

Belzona allowed the units to be repaired and protected from further erosion corrosion. These units have now been in service for 14 years with only minor touch-up required.
