# BELZONA EXTENDS THE LIFE OF HEAT EXCHANGER END COVERS

ID: 2237

**Customer Location:** Recreation Center, BC, Canada

**Application:** HEX-Heat Exchangers

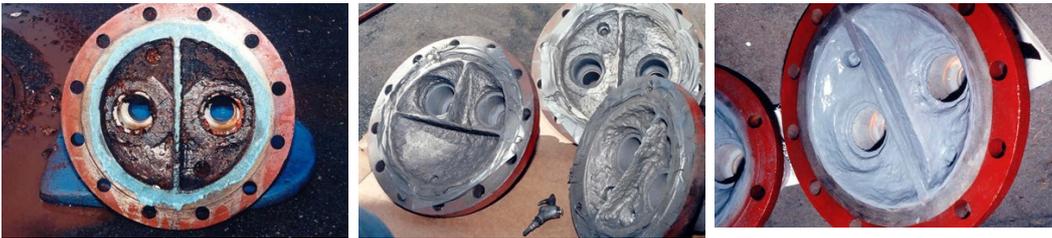
The heat exchanger unit end covers had become so badly eroded that they were potentially scrap.

- \* View of corroded end covers after they had been removed ,
- \* End covers after grit blasting ,
- \* End covers rebuilt and coated ,

The application was carried out in accordance with Belzona Know-How System Leaflets HEX-2 & 3.

Belzona allowed the units to be repaired and protected from further erosion corrosion. These units have now been in service for 14 years with only minor touch-up required.
