STEEL PLANT BACK ON LINE WITH BELZONA WRAP

ID: 2238

Customer Location: Steel Plant, Teesside, UK
Application Date: 2011

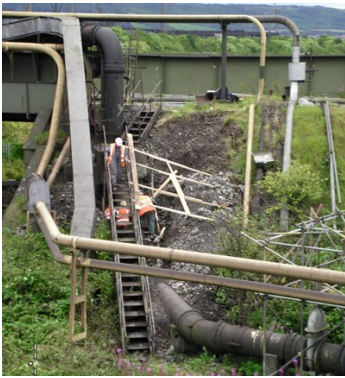
Gas leak on the 24 inch cast iron pipe was detected and once excavated a crack of 25cm length over the socket area was found to be the cause. The pipe was the gas main between the coke ovens and the power plant and so an immediate solution was required. The coke oven gas had a typical Internal pressure of 500mBar and client needed to reduce the repair period to a minimum.

- * 1. Site access to excavated pipe section ,
- * 2. Excavated 24 inch Gas Main with crack identified ,
- * 3. Completed Belzona 1121 wrap ,

The crack was terminated and V cut in accordance with Belzona Know-How System Leaflet VPF-08. Belzona 1121 was used to pack the gasket and create fillets on either side of the flange, before conducting a wrap repair in accordance with Belzona Know-How System Leaflet VPF-11a.
