# BELZONA® 1391 PROTECTS BEET COSSETTE MINGLER

Industry: *Sugar*  
Application: *TCC-Tanks and Chemical Containment Areas*  
Substrate: *Steel plate*  
Products: *\* Belzona® 1391 ,*

Customer Location: *Sugar factory in the United Kingdom*  
Application Date: *1999*

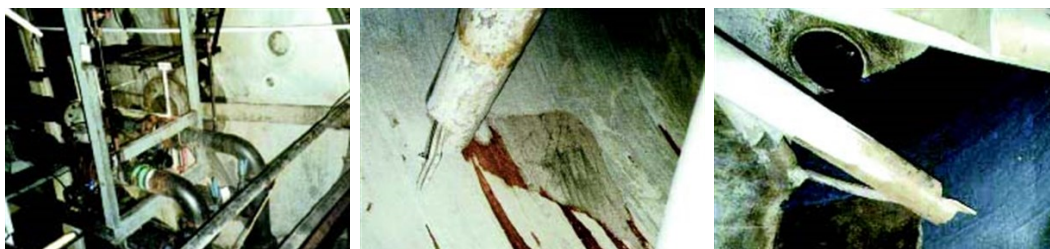
*Excessive corrosion and eventual failure of the existing glass flake protection system.*

- \* General view of the application site ,
- \* Equipment prior to surface preparation ,
- \* Application completed with Belzona® 1391 ,

The application was carried out in accordance with Belzona Know-How System Leaflet TCC-5.

Corrosion of the vessel if allowed to continue would have led to the operating efficiency of the mingler being impaired. The Belzona product lent itself to application within the confines of the vessel, and protection was applied to the most vulnerable areas of its surface.
