# BELZONA® 1391 PROTECTS JUICE HEATER END COVER

Industry: *Sugar*  
Application: *HEX-Heat Exchangers*  
Substrate: *Cast iron*  
Products: *\* Belzona® 1391 ,*

Customer Location: *Sugar factory in Ireland*  
Application Date: *1999*

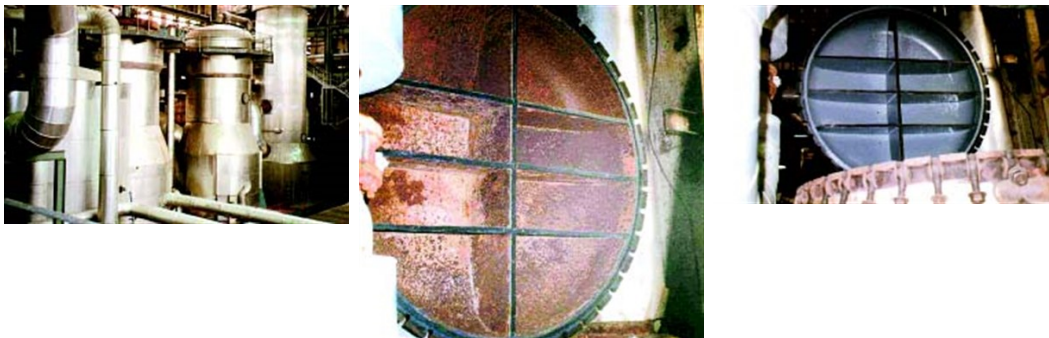
*Extensive corrosion pitting.*

- \* General view of the application site ,
- \* Equipment prior to surface preparation ,
- \* Application completed with Belzona® 1391 ,

The end cover of a juice heater.

The application was carried out in accordance with Belzona Know-How System Leaflets HEX-2.

Corrosion of the end cover if allowed to continue would have led to the operating efficiency of the juice heater being impaired. Belzona® 1391 was found after testing to be the only product to protect the cover at the operating temperature of 80°C.
